# Manhole Inspection Summary

Manhole # S13GG\_048MH

Insp Date: **2/23/09 2:24 PM**

**Location** Address: **2745 BAKER ST** Cross Street: **DUKELAND ST**

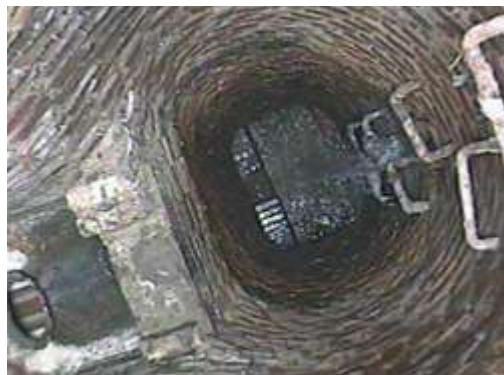
Defect 1

**Steps** Count: **12** Missing: **0** ☒ **Corroded**

**Surcharge** ☒ **Evidence Of Surcharge** Depth: **10** (ft.) ☐ Active Surcharge Present

EVIDENCE OF SURCHARGE AND  
CORRODED STEPS

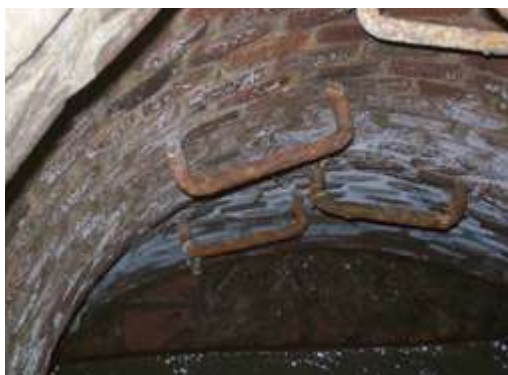
Defect 4

EVIDENCE OF SURCHARGE

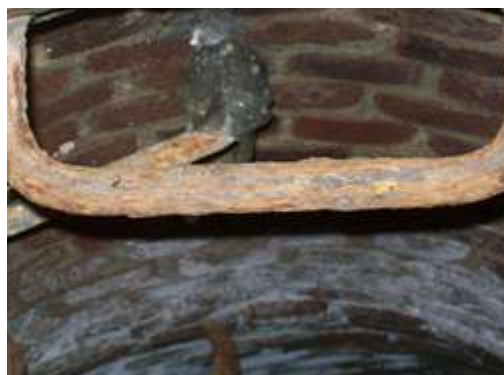
Defect 2

CORRODED STEP

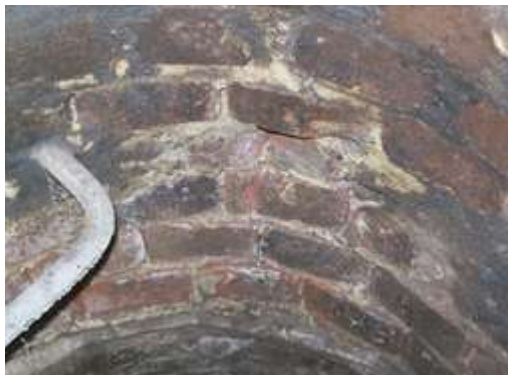
## Defect 3

Condition: ☐ Sound ☐ Cracked ☐ Root Intrusion ☒ **Loose Brick** ☐ Deteriorated

loose bricks in corbel

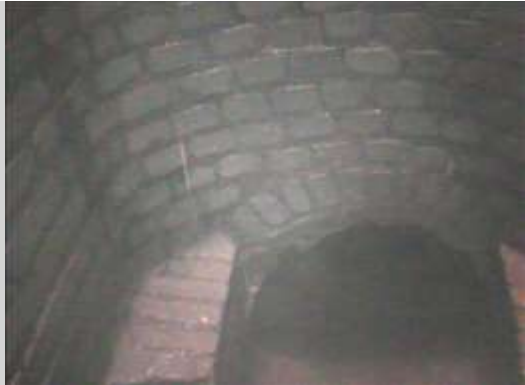
12 O'Clock Outflow

27 in. Circular Gravity Sewer  
Pipe Out @ 12 O'Clock

Invert Depth: **22.23** (ft.) Flow Characteristics: **Slow**

Infiltration: **None**

Pipe Seal Cond: **Sound**

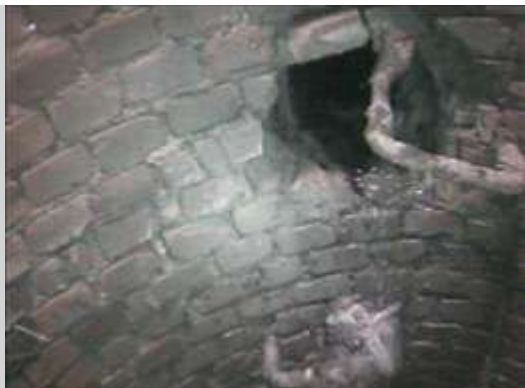
3 O'Clock Inflow

8 in. Circular Gravity Sewer  
Pipe In @ 3 O'Clock

Invert Depth: **10.10** (ft.) Flow Characteristics: **Slow**

Infiltration: **None**

Pipe Seal Cond: **Sound**

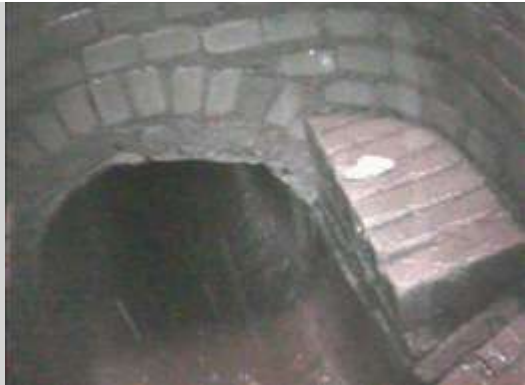
6 O'Clock Inflow

27 in. Circular Gravity Sewer

Pipe In @ 6 O'Clock

Invert Depth: **22.19** (ft.) Flow Characteristics: **Slow**

Infiltration: **None** Pipe Seal Cond: **Sound**

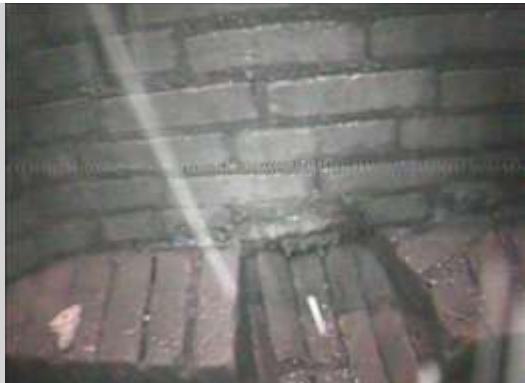
9 O'Clock Inflow

8 in. Circular Gravity Sewer

Pipe In @ 9 O'Clock

Invert Depth: **7.97** (ft.) Flow Characteristics: **Slow**

Infiltration: **None** Pipe Seal Cond: **Sound**

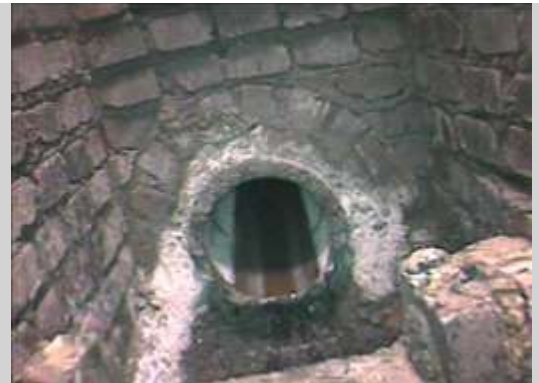
Drop In @ 9 O'Clock

Drop: **Inside** **Direct**

Inv Depth: **21.10** (ft.)

Drop Condition: **Open**
